Bridger Range, Ramp Spencer Jonas Stability: HS105 **Bridger Range** Sat Nov 11 14:45 2017 Air Temperature: Stability Test Notes ΜТ Co-ord: 45.82853N, -110.93153W Sky Cover: BKN Elevation: 8000 ft Slope Angle: Precipitation: NO Aspect: NE Wind Loading: Wind: E Light Breeze Specifics: Ski tracks on slope; We skied slope Crystal ρ

Advisory Region Bridger Range Bridger Range, 2017-11-13

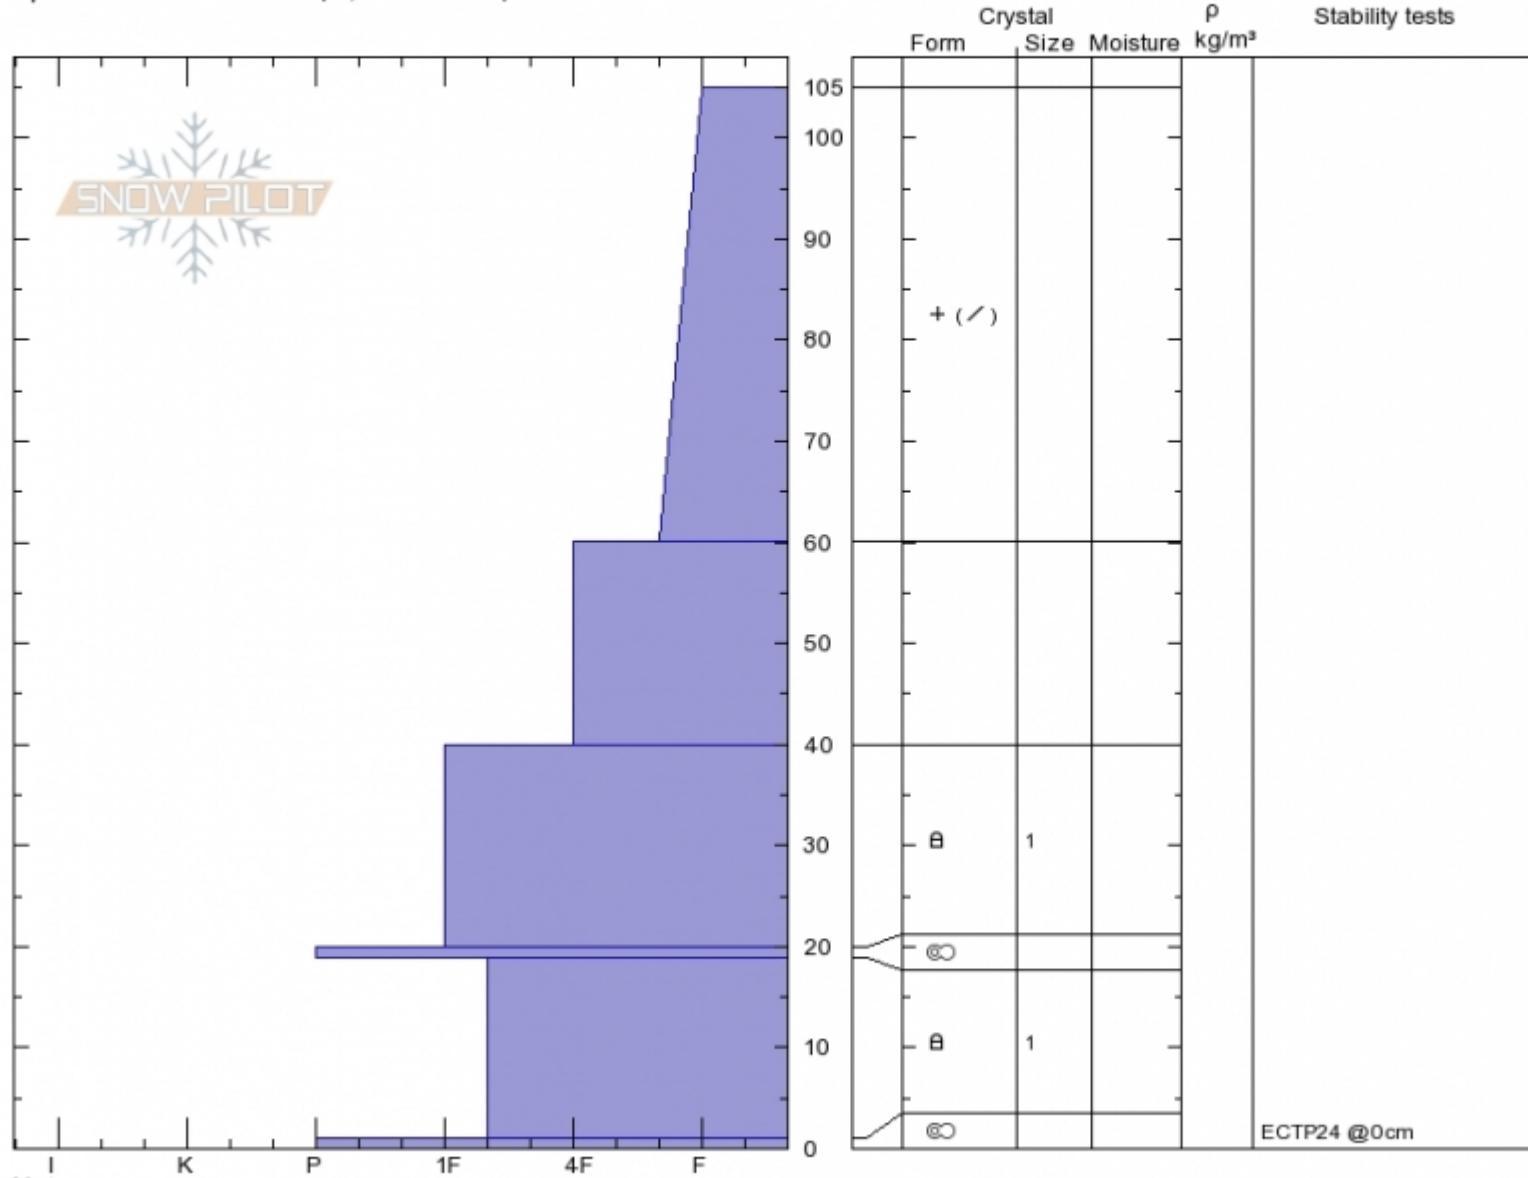
Notes: There was an air pocket between the ice crust that formed the bottom layer and the ground. The column failed when the ice bro little ground that it was attached to, a small root and rock at the back of the column. Our layer of concern was the old September no sign of instability at its interface. It is hard to interpret the ectp as a sign of instability, it seemed to be more an issue of gro specifically beneath the column and not an indicator of overall instability at the ground.
